**SUBJECT: REPORT OF 2017 ANNUAL INSPECTION OF TAILING IMPOUNDMENTS
AND PONDS, HOMESTAKE GRANTS PROJECT, GRANTS, NEW MEXICO**

On November 8, 2017 the undersigned performed the annual visual inspection of the tailing impoundments and evaporation ponds at the Homestake Grants Project located at Grants, New Mexico Tom Wohlford (Closure Manager of Homestake Mining Company) and Reginald Shirley (contract engineer with Brown and Caldwell) accompanied me on the inspection As the Responsible Engineer for these impoundments, I am required to annually inspect the stability and functionality of the impoundments per NRC Radioactive Materials License SUA-1471, Condition 12 and DP-200, Condition 52.

Homestake Grants Project, Grants, New Mexico

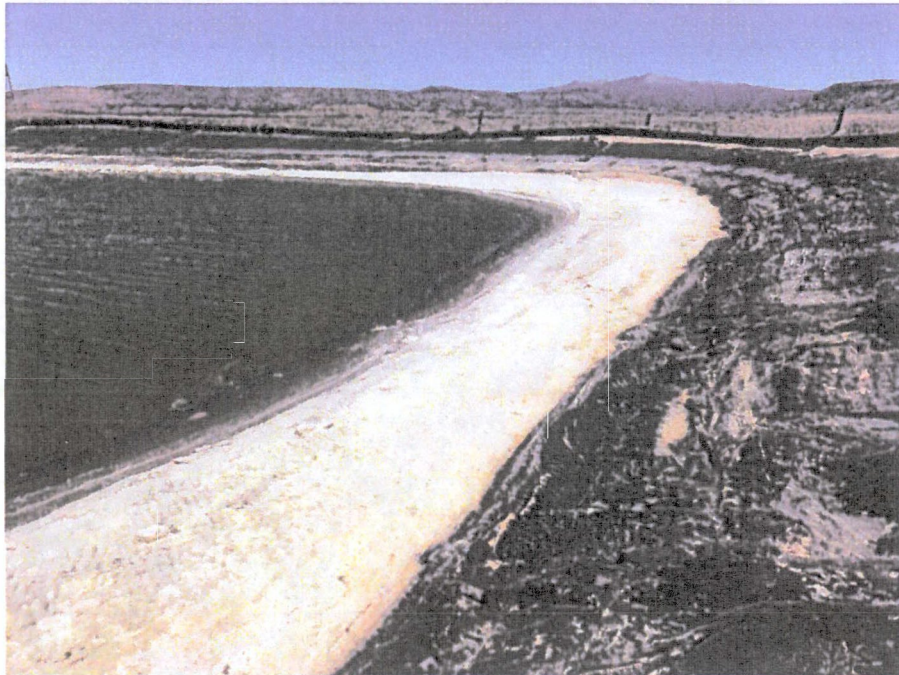
The small impoundment (location of evaporation pond #1, or EP1) remains in generally good condition The slumps in the subgrade fill of the south inslope of EP1, under the pond liner along approximately 200 feet of the pond westward from the southeast corner (Photo 1), have not visibly changed in 2017, and the liner remains intact Similar but more limited slumps are now visible along the east inside slope of EP1 (Photo 2) During 2017, the water level was lowered for part of the year, making it possible to examine the precipitated sludge that has accumulated since 1990 (Photo 3) Weathering cracks have developed at several locations in the pond liner The liner remains functional despite these conditions, but Homestake initiated an engineering feasibility assessment of options to address the issues related to aging of EP1, including the slumps in the liner (letter Wohlford to Meyer, 4/24/17)

Photo 1 – EP1 liner near the southeast corner. Slumps along right side.

Until the EP1 options are evaluated and a course of action taken, the slumps along the inside slopes of EP1 should be protected against further displacement to protect the liner. Site staff should note any changes in the slumps and in the condition of the liner.

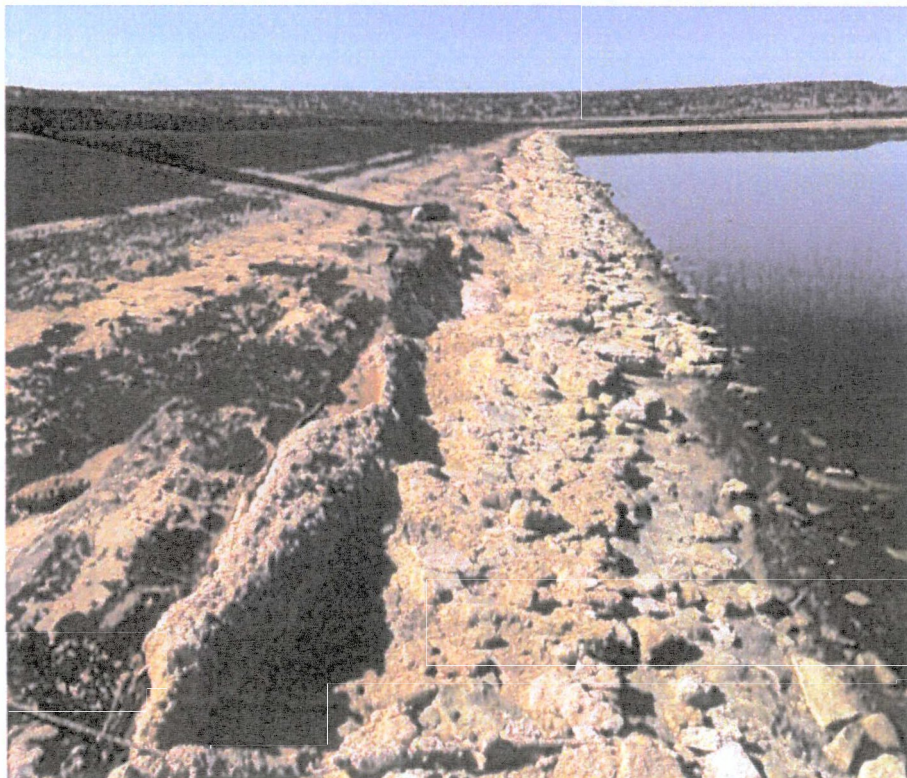
Photo 2 – EP1 east slope Slumps below normal pool level

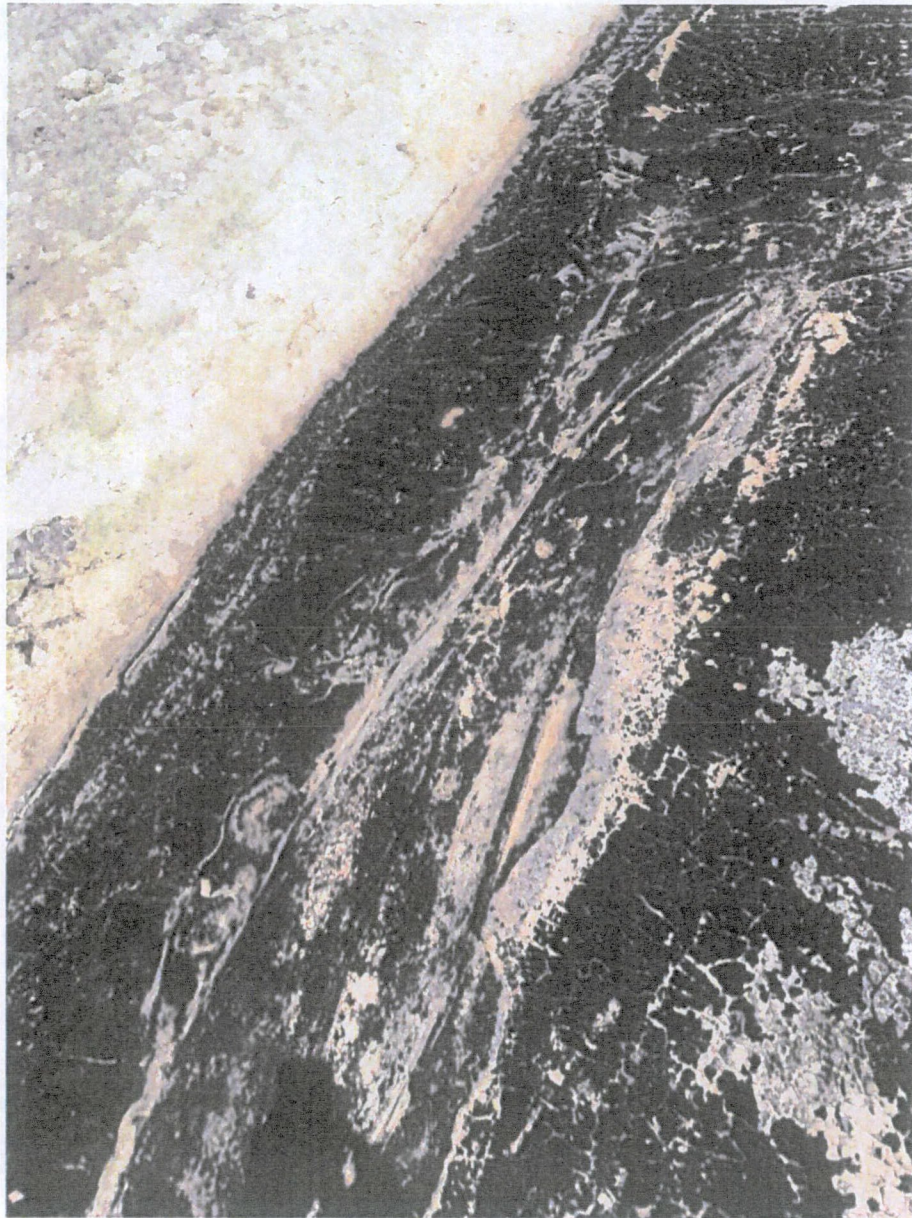
Photo 3 – Close-up of precipitated sludge of the EP1 liner.

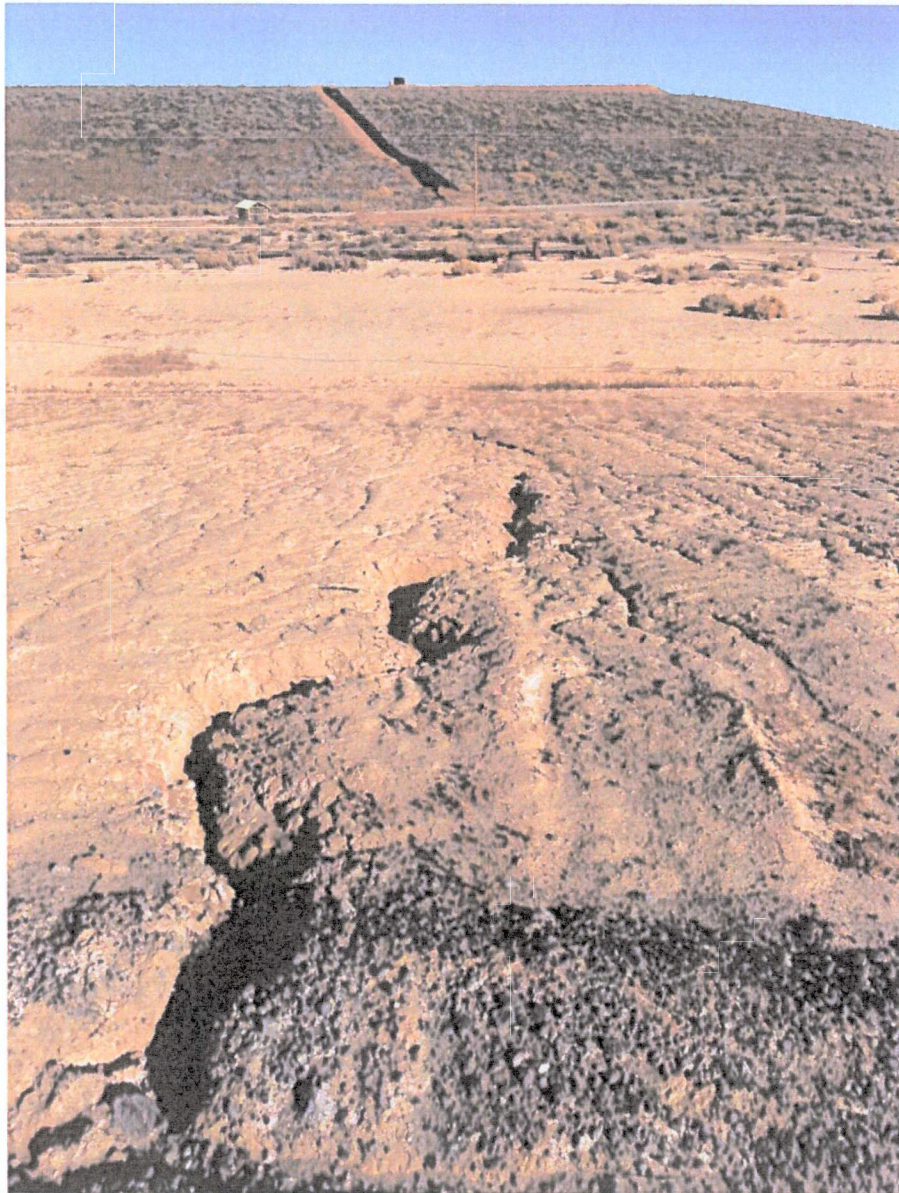
Homestake repaired rills during the 2016-2017 winter, but rills have developed again on all of the small tailing pile out slopes during 2017. On the east out slope, rills were up to 6 inches deep. On the southeast and north slopes, rills were generally 4-8 inches deep but up to two feet deep in a few places downslope from low spots in the EP1 perimeter berm where runoff was concentrated (Photo 4). The west and southwest slopes had minor rilling up to 4 inches deep. HMC has prepared an erosion mitigation plan that includes earthwork to fill rills and deployment of erosion control blanket. Implementation of this plan is expected in early 2017.

Photo 4 – Major rill in EP1 north outslope.

The undersigned advised HMC that rill management and grade control are needed annually to maintain erosional stability of the small tailing impoundment, the evaporation ponds, and the interim cover of the LTP. Perimeter berms on the covers of the STP and LTP should be maintained to minimize the potential for surface runoff to create concentrated sideslope flows and sideslope rilling. In response, HMC has developed a plan for erosion control on EP1, with applications for EP3, as well.
